TECHNICAL DATA SERIES

SDI 122 - 15

Installation Troubleshooting Guide for Standard Steel Doors and Frames

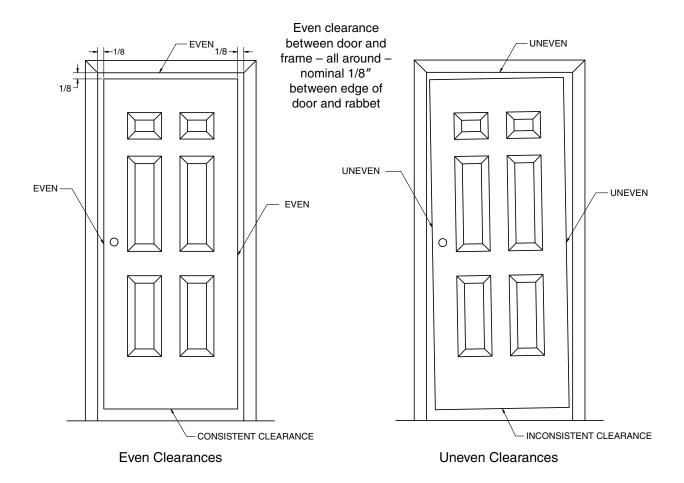
Is door sagging?

Uneven clearances frequently result from improper installation of frames and frame anchors. The condition, characterized by lock edge clearances narrow at the top and wide at the bottom, is called "door sag." The following suggested adjustments may correct the condition

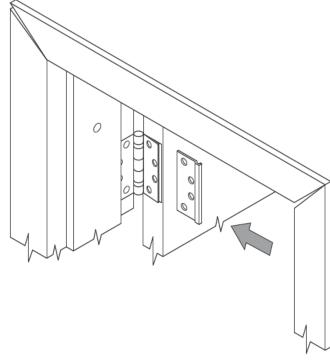
Remove top hinge filler for nonhanded doors

The improper clearance condition may be improved by removing the top hinge leaf attached to the door and taking out the filler (hinge filler) from behind the leaf. Once completed, reattach hinge leaf to door. A hinge filler is used on all non-handed doors.

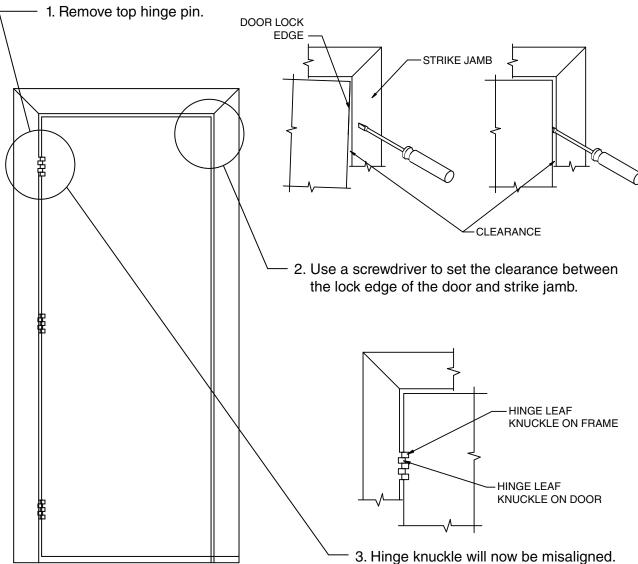
Reswaging hinges

The following example shows how a hinge leaf can be reswaged to correct minor improper door/ frame clearances. This particular method allows the reswaging to be accomplished while the door remains in the opening and the hinge leaves remain on the door and frame. The example shows a top hinge reswaged to correct a sagtype condition. However, any of the hinges can be reswaged in this manner to compensate for conditions opposite to that of a sag condition.

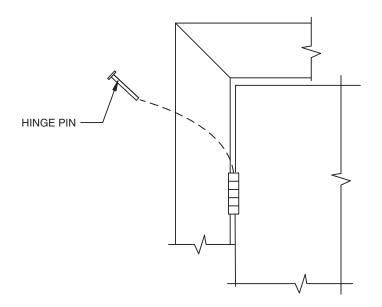
4. Reswage and align hinge knuckles.

As shown, the hinge leaf knuckles on the door move to a new location once the clearance at the strike jamb is set. The hinge leaf knuckles on the frame must now be reswaged (bent) to align with the new location of the hinge leaf knuckles on the door. The simplest way to do this is to use a 5%'' - 11/16'' tube wrench (a crescent wrench will do as a second choice). Simply slip the tube wrench down around the 1^{st} knuckle and align it with the new location. Once the first knuckle has been aligned, the wrench will now slip down to the 2^{nd} knuckle for alignment. Repeat the process on the third knuckle.

NOTE: As always, caution should be exercised when the hinge leaves are not removed. **Excessive** pressure could damage doors/frames. As an alternate reswaging method, the hinge can be removed and clamped in a vise for reswaging.

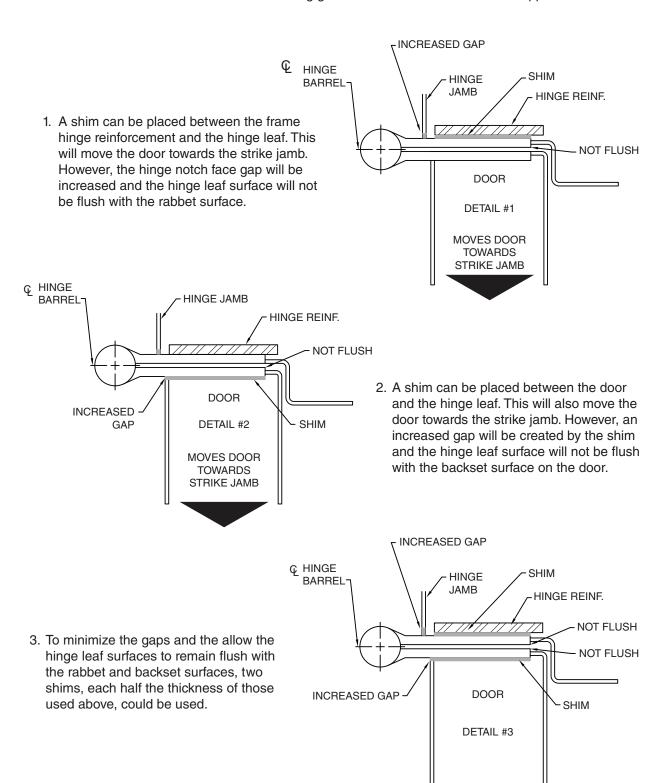
HINGE BIND AGAINST RABBET

Normally, hinge bind is found between the door and rabbet. There are several ways of shimming which will move the door in different directions. The following guidelines should be used in shim applications.

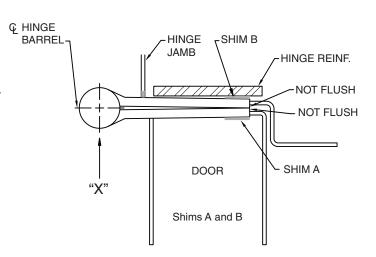
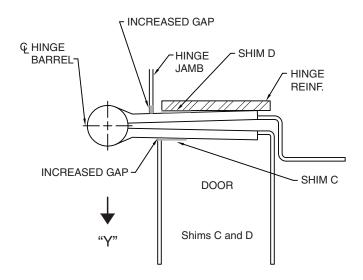
HINGE BIND AGAINST STOPS

Hinge bind against the frame stops is possible field condition. There are several ways of shimming which will move the door in the desired direction. The following guideline should be used in shim application.

- 1. Using Shim "A" only, door will be relocated in direction of Arrow "X".
- Using Shim "B" only, will move both door and centerline of hinge barrel in direction of Arrow "X".
- Using both Shims "A" and "B" will relocate the door in direction of Arrow "X" by a greater amount than by using Shim "B" alone.
- 4. Using Shim "C" only, door will be relocated in direction of Arrow "Y".
- Using Shim "D" only, both door and centerline of hinge barrel will move in direction of Arrow "Y".
- 6. Using both Shims "C" and "D" will relocate the door in direction of Arrow "Y" by a greater amount than by using either "C" or "D" alone. The centerline of hinge barrel will be relocated the same as by using Shim "D" alone.

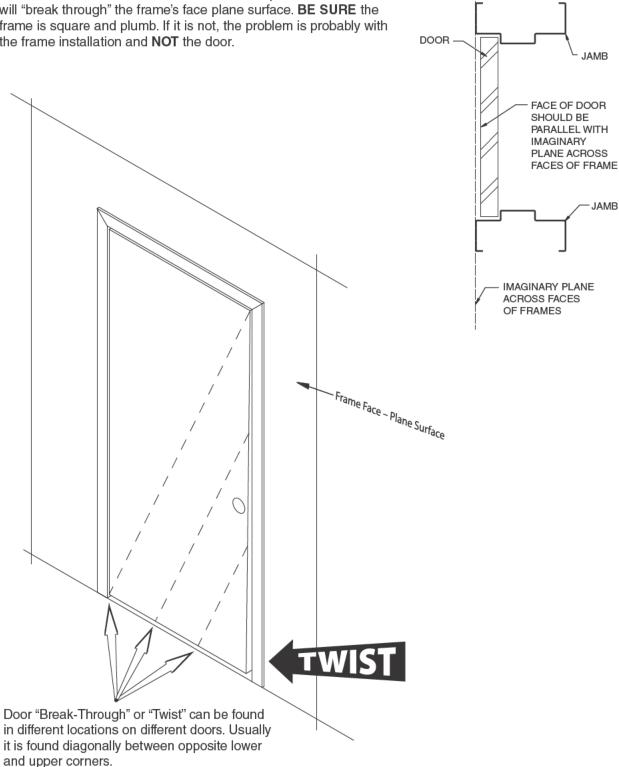
TWISTED DOOR

Normal installation results in the plane of the door face being parallel with the plane of the frame face. If the frame is square and plumb, all face surfaces of the frame will be in the same plane. A twisted door will "break through" the frame's face plane surface. BE SURE the frame is square and plumb. If it is not, the problem is probably with the frame installation and NOT the door.

For various conditions of twisted doors, refer to page 8.

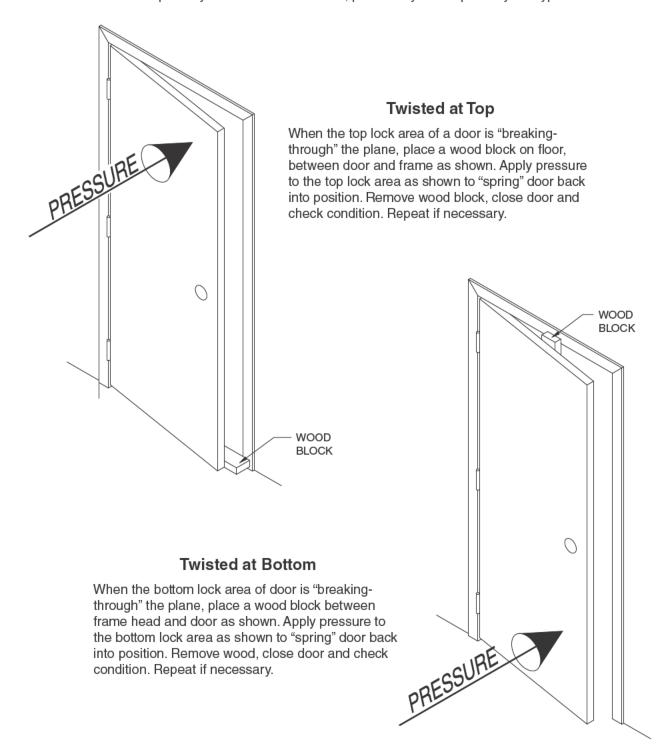
TWISTED DOOR ADJUSTMENTS

When required, it is possible to "spring" the door back to (or much closer to) its ideal position of being parallel with the plane across the faces of the frame. This can usually be done with the door remaining in the frame. A piece of wood blocking must be placed between the door and frame. Pressure is then applied at the twisted area to "spring" the door. However, caution should be exercised on drywall installations since the frame could possibly work lose from the wall, particularly with slip-on drywall type frames.

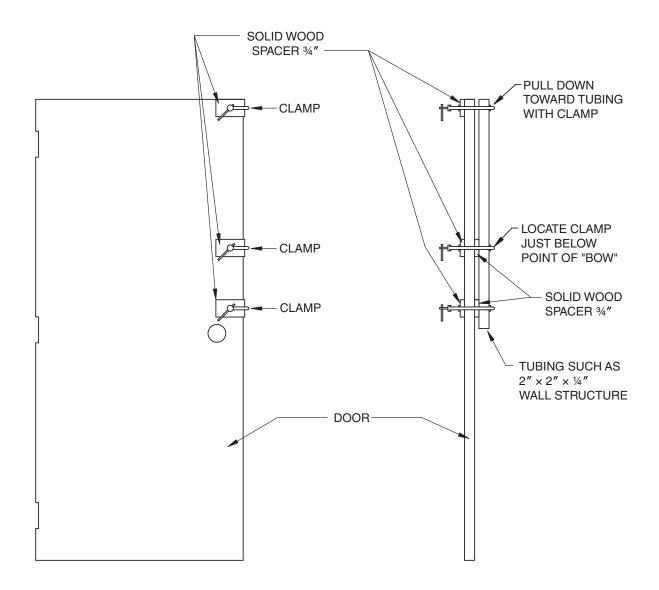
TWISTED DOOR ADJUSTMENTS (continued)

An alternate method can also be used which will allow the door to remain in the opening. This method might be appropriate in drywall installations as previously mentioned. Although the example shown deflects the top half of the door, this method could be used on the bottom half of the door as well.

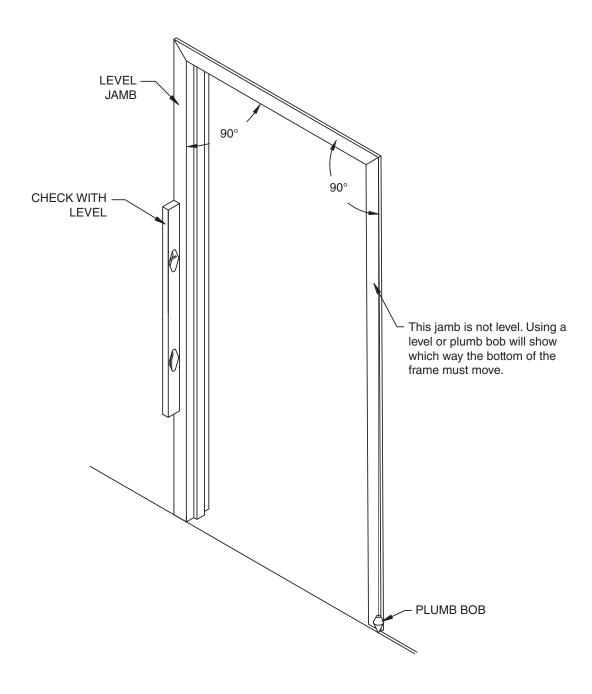
TWISTED FRAME

Wall conditions and anchoring methods can cause the frame to be "twisted" in the opening. The two jamb (hinge and strike) faces are not in the same plane as discussed in the twisted door section. This can be checked by using a level and/or plumb bob. Frames do not have adjustments when it comes to "twist".

The "twist" condition is generally caused by the wall conditions. The frame jamb faces are prevented from being set in the same plane because the walls are out of plane to begin with.

The options available to correct this problem depend, to a large extent, on the wall construction.

For various conditions of twisted frames, refer to page 11.

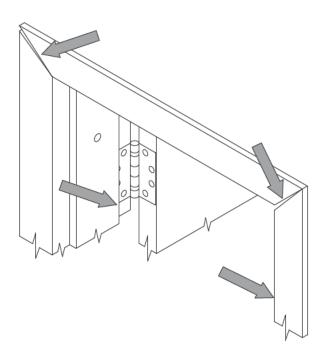
IMPROPERLY SET FRAME (A)

This condition can be corrected by adjusting the compression anchors in and/or out of each jamb as required. Loosen the corner clip screws if the frame is so equipped before making adjustments; retighten when finished. The compression anchors must be adjusted (turned) in opposite directions to allow the jambs to move.

For the illustration shown, the strike jamb compression anchor screw must be turned counterclockwise to retract the compression anchor and give room for the frame to be adjusted back into position using the hinge jamb compression anchor. The hinge jamb compression anchor screw is then turned clockwise to advance the anchor and push the frame towards the room made at the

strike jamb. The frame should be brought into square with the header and the hinge jamb compression anchor. Once this is done, the strike jamb compression anchor screw can be turned clockwise, advancing the anchor snug against the stud. The corner slip screws should then be retightened.

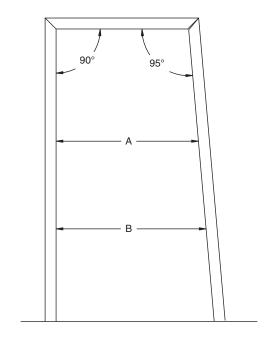
IMPROPERLY SET FRAME (C)

One corner is properly set at 90° while the other corner is greater or less than 90°. The dimension taken at point "A" will constantly change when checked at various points going towards point "B." The corner miter will not properly align between the header and jamb which is not set at 90°

The jamb which is not 90° to the header must be moved. To correct this condition, the sill anchor must be loosened to allow the bottom of the jamb to be moved in or out as required. In the case of the snap-in type sill anchor, the baseboard trim may have to be removed to gain access to the anchor. This type of anchor is generally used because it can be hidden by covering it with the baseboard trim.

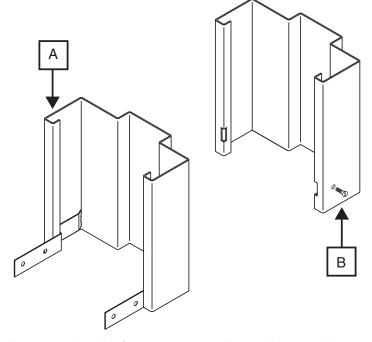
Typical toed-in or out condition

"A" shows an anchor which will be covered up by the baseboard trim. To gain access to this anchor the baseboard trim must first be removed. Next, the nails or screws holding the anchors to the wall must be removed. This will loosen the jamb and allow it to be squared in the opening.

"B" illustrates a screw going through the face of the frame into the wall. This holds the sill of the frame in position. This screw is exposed and is readily accessible. Removing the screw will loosen the jamb and allow it to be "squared-up" in the opening. If both jambs are toed in/out, they both should be "squared-up." This can be checked by taking measurements as shown

below. Both the "A" and "B" dimensions will be the same when the frames are properly set. However, the frame jambs must be plumb, level, and square with the head of the frame.

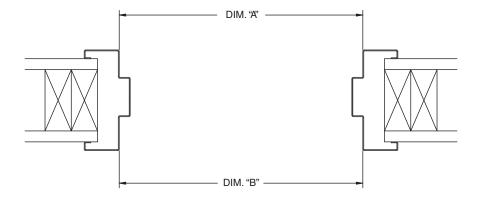
If both jambs are toed in/out, they both should be "squared-up." This can be checked by taking measurements as shown above. Both the "A" and "B" dimensions will be the same when the frames are properly set.

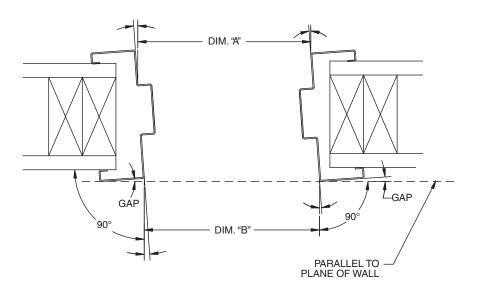
The below figure shows a condition which can give the impression that the frame is properly installed. Both dimensions "A" and "B" will be equal but the frame will not be square in the opening. Both jambs can be twisted to create a parallelogram. This can be checked by placing a straight edge across the face of both jambs (the straight edge is represented by the dotted line shown below. The straight edge should set flat across both faces at the same time. If the jambs are twisted, a "gap" will be created as shown in the illustration. The "gaps" will be to the same side if a parallelogram was created. The gaps could also be to opposite sides as shown in the Typical Toed In or Out Condition figure on the previous page.

This condition can be corrected as outlined for the other "toe out" or "toe in" examples.

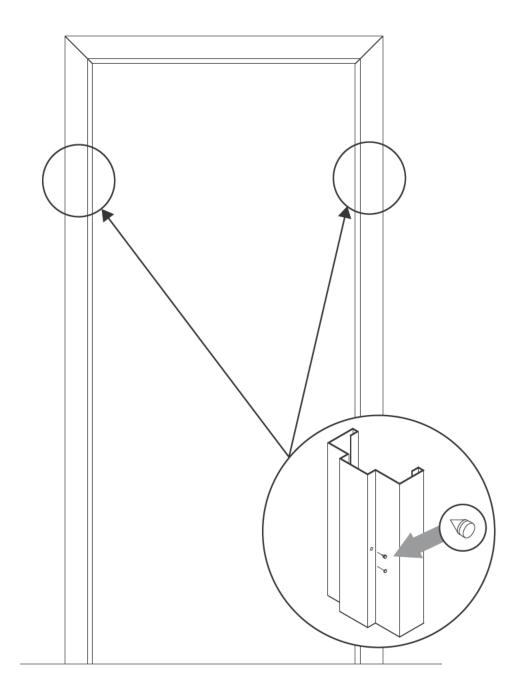
SILENCERS

Some manufacturers provide a silencer hole in the frame stop to accept a push-in silencer. A "stick-on" silencer is also available for application to frames without the silencer hole. The silencer acts as a "rubber bumper" which evenly holds the door off the stop at a constant distance. If the door is held off of the stop rather than being allowed to move slightly towards the stop, the latch tube will fit tighter into the strike. Three silencers are placed on the strike jamb, one toward the top of the jamb (nearer the header) and one toward the bottom of the jamb (nearer the sill) and the third near the strike preparation.

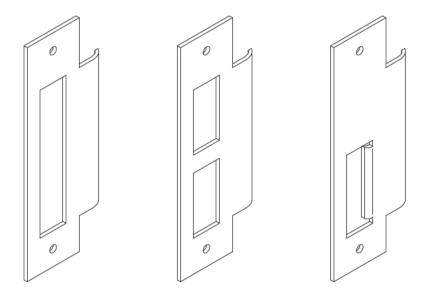
PROPER STRIKE

Is the proper strike plate attached to the frame?

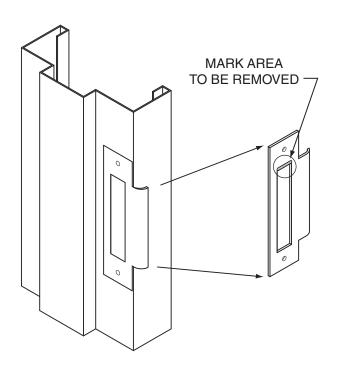
Minor location adjustments usually can be accomplished by altering the strike plate. The strike plate alteration would "extend" the opening to allow the latch tube to properly engage the strike. This is similar to the section "Lock Fits Too Tight in Strike" except that the amount of material removed from the strike is greater. This could compensate for minor mislocation of the strike plate on the frame and/or location of the lockset on the door. These general steps should be followed for modifying the strike plate.

- Mark the area on the strike plate which must be removed.
- · Remove strike plate from frame.
- Center punch corners of area to be removed and drill a 1/8" diameter hole in each corner.
- Use a saber saw and cut from the existing opening up to the ½" diameter holes.
 The remaining material between the two ½" holes should be filed away.
- Dress off all rough edges and corners with a file. This must be done since any irregular edges or edges with burrs could cause the latch tube to "drag" or "hang up" in the strike plate.
- Reassemble strike plate to frame and check alignment with lockset on door as well as latch tube function in and out of strike plate.

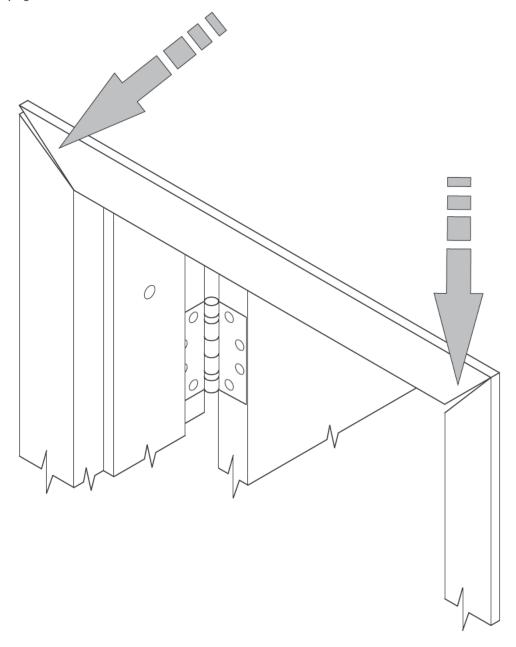
MITER NOT CLOSED ON FRAME

The major cause of miters not properly lining up and "closing" is incorrect installation. The effects of improper installation on miter seams are covered under the previous section of "Frame Set Out of Square." This section should be referenced for detailed explanations of conditions which could occur, and solutions for correcting the problems.

This condition could also be caused by conditions as explained in the "Frame Loose on Drywall" section—figures on page 28.

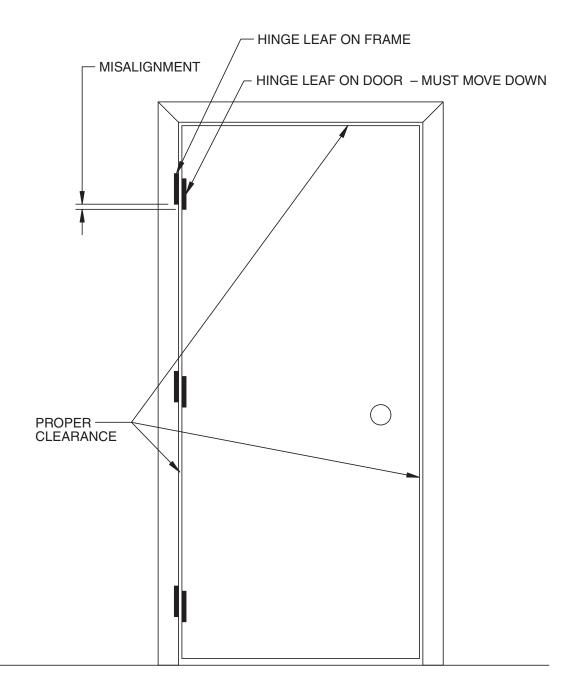
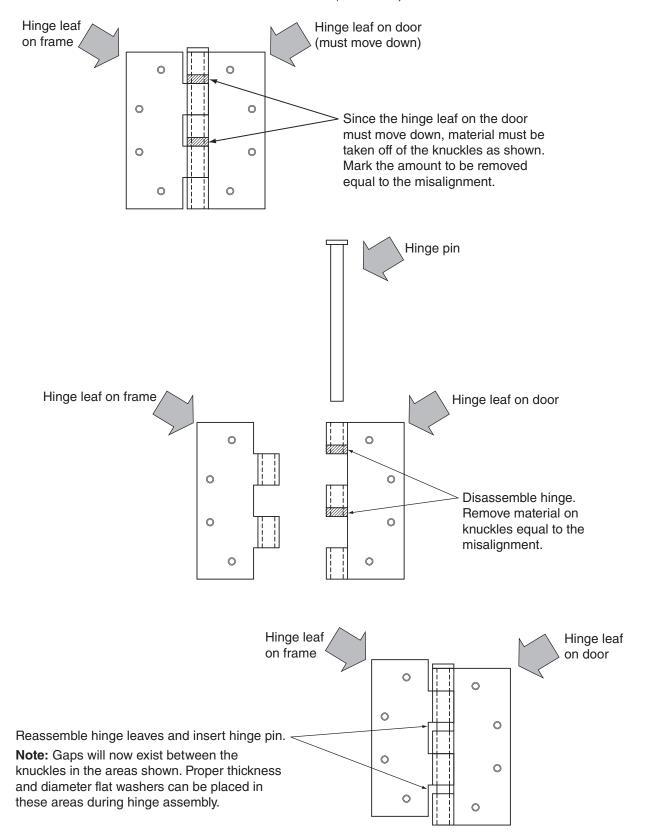
FRAME AND DOOR HINGE MISALIGNMENT (continued)

Frame and door hinge misalignment can cause a variety of problems. When misalignment occurs, either the door's hinge locations or frame's hinge locations are slightly off. This can apply to retrofitting existing openings where either the door or frame is being replaced, but not both. When new doors and frames are provided from a single manufacturer, this problem does not exist.

The example shown on the following page reflects the dropping of the hinge leaf which attaches to the door from its relationship to the hinge leaf on the frame. However, by removing material from the opposite end of the knuckles, the door hinge leaf could be raised as well. The frame hinge leaf can also be relocated in similar fashion.

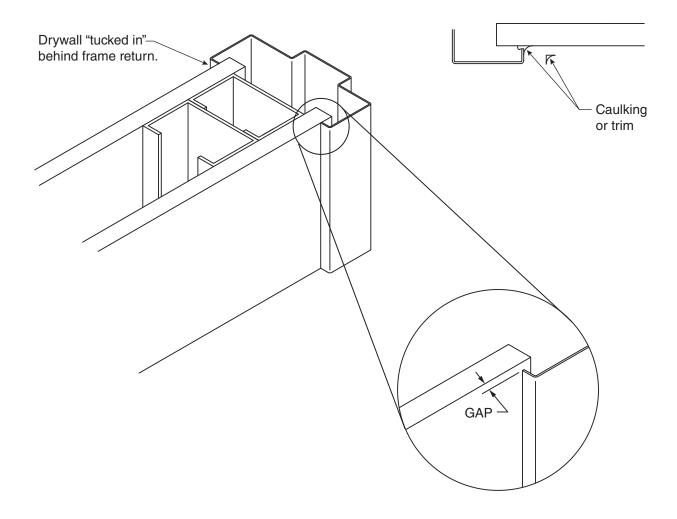
WELDED/SNAP-IN STEEL, OR WOOD STUD ANCHORS

Some frames use welded or snapped-in steel or wood stud anchors. These frames are installed prior to the drywall material being attached to the studs. The drywall can either be "butted-up" against the return of the frame or be "tucked in" behind the return of the frame. Only in the installation where the drywall is "tucked in" behind the return can there be a condition where the frame is loose on the drywall. This gap could be uniform along the entire length (height) of the jamb or could be only in certain areas. Since the frame cannot be removed, the only available options are to caulk the gap or cover it with trim.

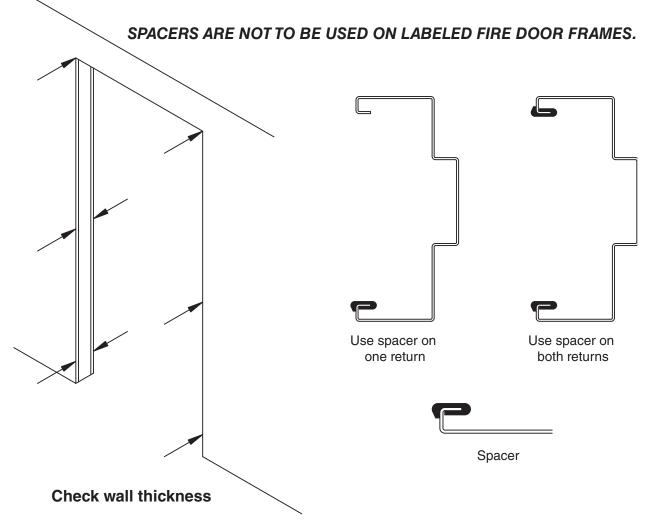
- 1) The first condition is a uniform gap along the entire length (height) of the frame jambs. The frame should be removed from the opening and the wall thickness checked at numerous places around the opening. These measurements should be compared to the job specifications. If the wall thickness is undersize, two options are available.
 - a) If the gap is relatively small, the use of caulking or trim can be considered to cover the gap when the frame is installed.
 - b) If the gap is larger, the use of "spacers" can offset the lacking wall thickness. The use of spacers requires that the frame be removed from the opening, the spacer(s) attached, and the frame reinstalled. The spacers can be used on either one or both of the frame returns which would result in spacers on either one side or both sides of the wall. Spacers are available from the frame manufacturer.

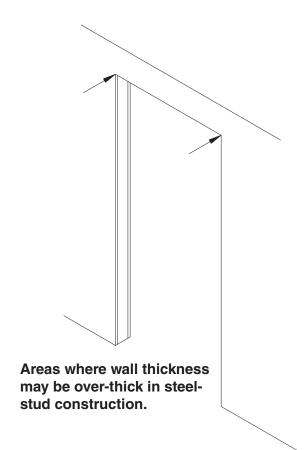
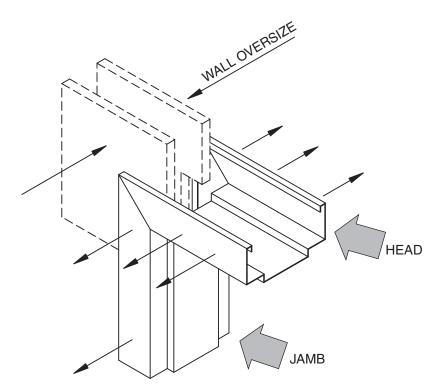
2) The second condition would be a gap that changes along the length (height) of the jamb. This condition is generally found in steel stud construction and results in "over thick" walls in the upper corners of the opening, refer to Figure 5. This is usually a direct result of how the steel stud headers were attached to the vertical steel studs to form the opening. When the wall is oversize (in this area) it will force the header and jamb miters to spread apart and actually open up the throat dimensions to accept the oversize wall. This will cause the corners of the frame to be extremely tight on the wall and as you progress down the jamb, a gap will begin to develop and then gradually disappear closer to the floor, see figure on following page.

Frame spreads apart with oversize wall.

HEAD

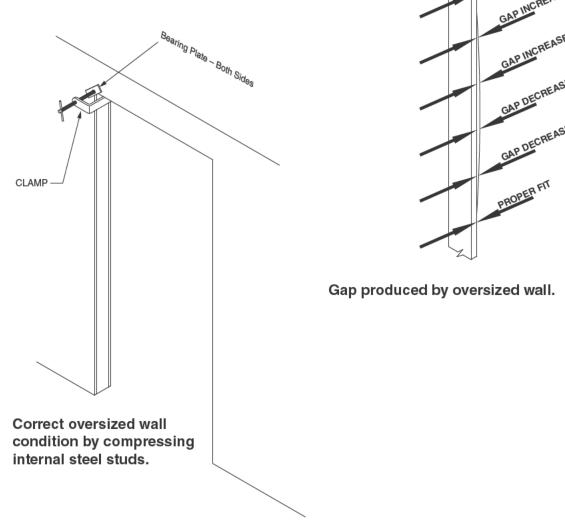
This condition should be reported to the appropriate jobsite personnel. The condition can be corrected by putting a bearing plate on each side of the corner and compressing the internal steel studs with a clamp. However, the responsibility for correcting this condition belongs to the sub-contractor responsible for the actual wall construction.

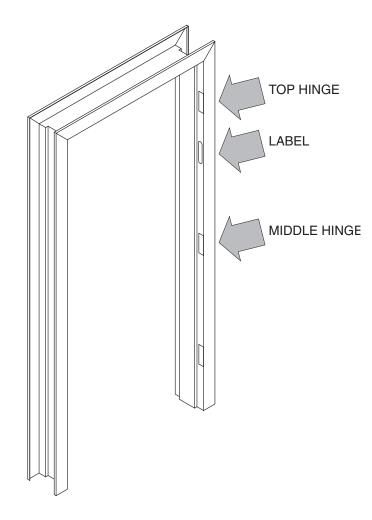
All labels on fire rated frames are located on the hinge jamb between the top and middle hinge (see figure below). It should be noted that some frames have an embossed label, rather than a surface-attached label. The embossed label is stamped into the frame rabbet and can be painted over.

- Borrowed light frames may have labels applied to soffit of frame due to glass and glazing bead location.
- Frames incorporating continuous hinges may have labels applied to soffit or frame head.
- · See manufacturer's procedures.

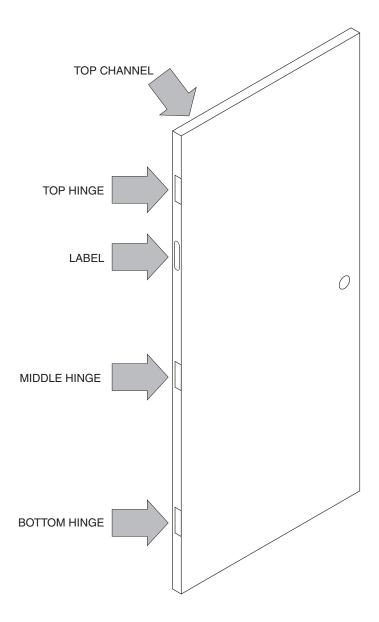
Labels on fire-rated doors are located in one of two places, either between the top and middle hinge, or on the top channel (see figure). Be sure you are looking for the label in the correct location.

- Labeled doors incorporating continuous hinges may have labels placed on the top channel of the door. Check with the individual manufacturer to determine location of label.
- Labeled hollow metal transom panels may need to be removed to verify labeling if fully enclosed by a fixed hollow metal frame.
- See manufacturer's procedures.

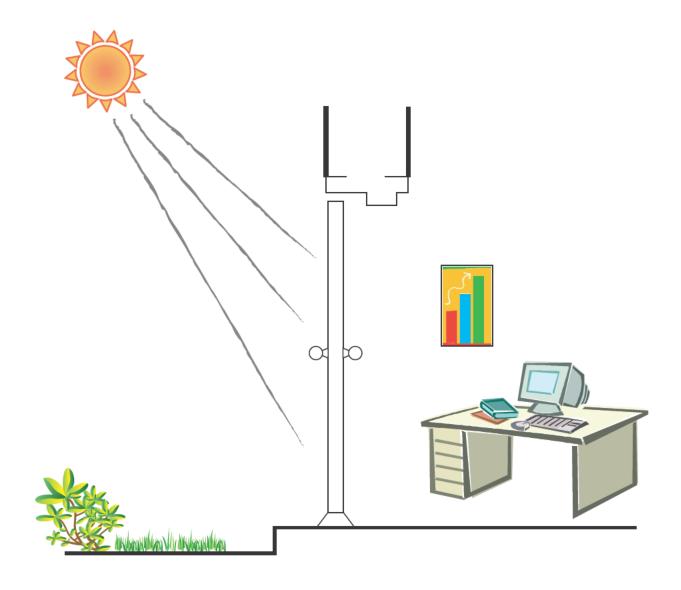
Installers need to be aware of a condition known as Thermal Bow. Thermal Bow is a temporary condition which may occur in metal doors due to the inside-outside temperature differential. This is more common when the direct rays of the sun are on a door surface. This condition is temporary, and to a great extent depends on the door color, door construction, length of exposure, temperature, etc. This condition can often be alleviated by painting the exposed surface a light color. Thermal bow can occur in reverse under extremely cold conditions. Typical symptoms of thermal bow are hardware latching difficulty and door clearance issues.
